Lower Nailbourne Infiltration Plan

Appendix A – Status of Planned Actions July 2024

from
**Southern
Water**

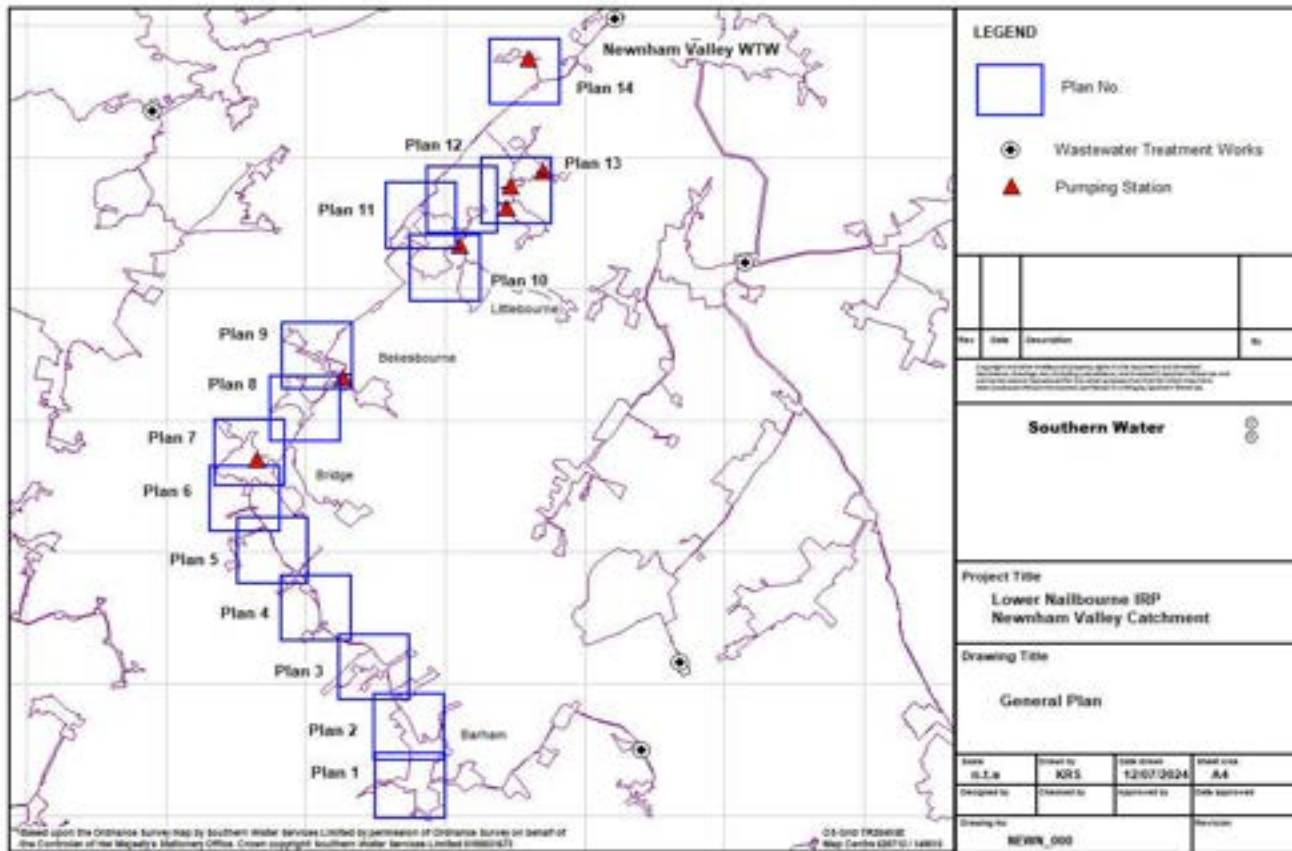
Reference Plan

Action	km
Length Surveyed	85.06
Length with no work required	72.57
Length sealed	9.27
Length to be sealed	3.22
Manholes sealed	6
Manholes to be sealed	1
